REGION 6 EXECUTIVE SUMMARY

TOPIC: San Jacinto River Waste Pits Superfund Site

DATE: January 5, 2016

PURPOSE: For Information – Cap Repair

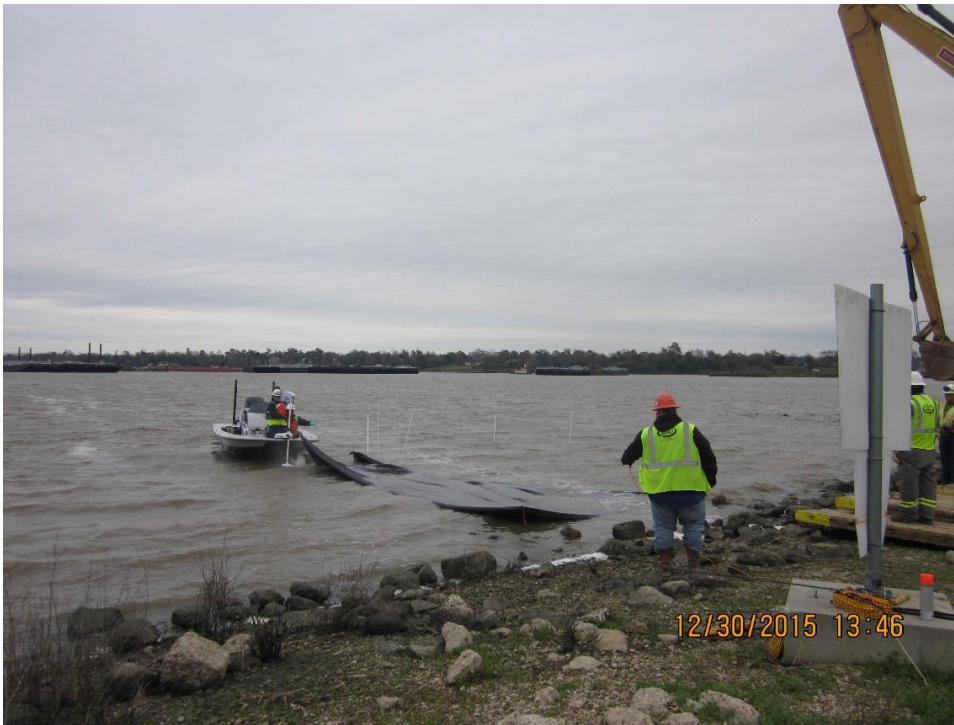
Placing geotextile over repair area.

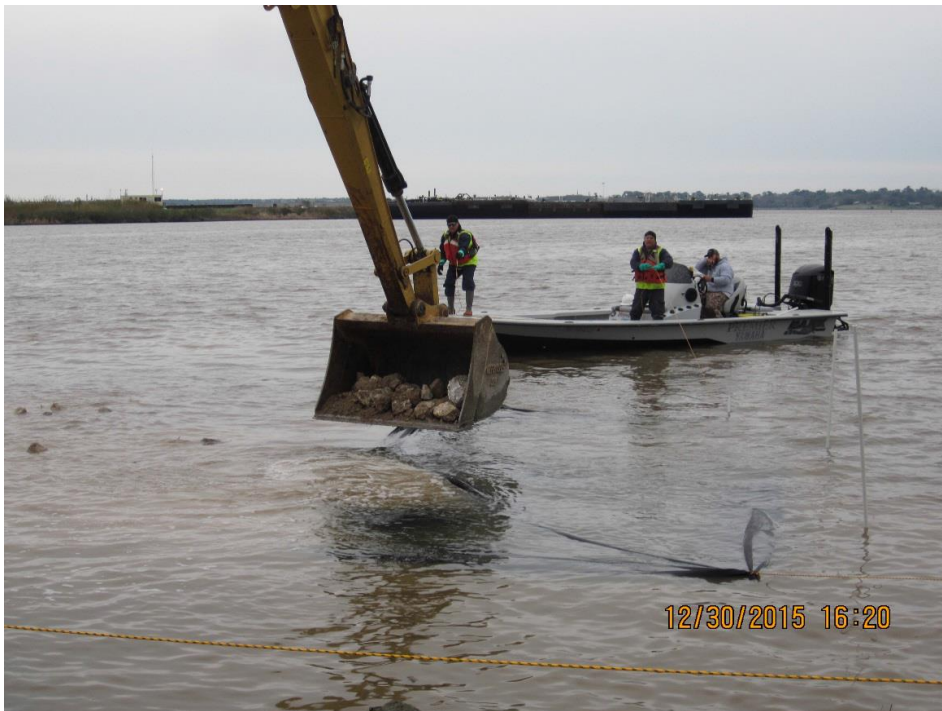
Placing Type C Rock (6" median diameter) on top of geotextile layer in repair area.
